## **Assessment of Dam Safety of Coal Combustion Surface Impoundments**

**Indianapolis Power & Light Company**

**Harding Street Generating Station**

**June 4, 2010**

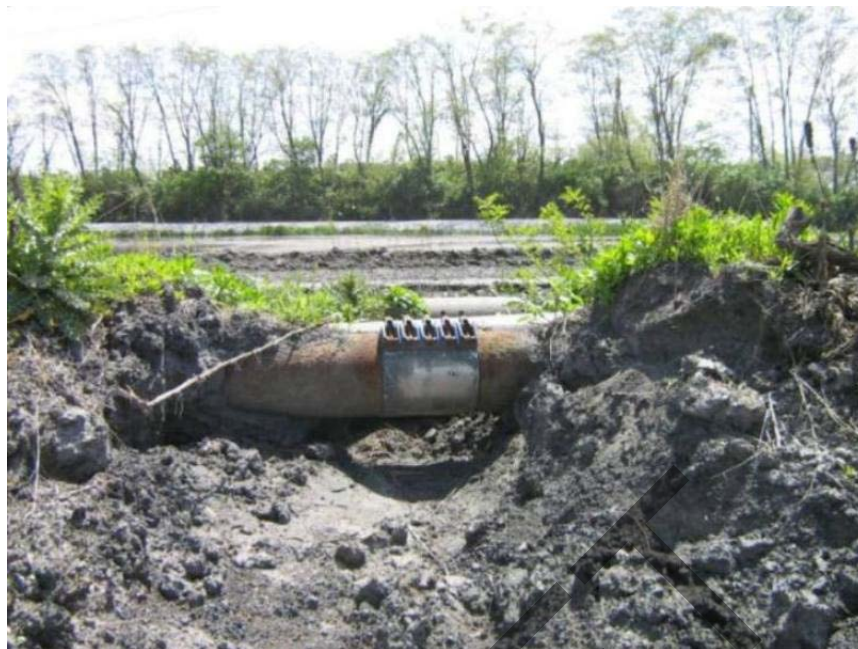
The crest of Ash Pond 1 appeared to be in satisfactory condition (Photographs 1, 8, 11, and 12). The crest was approximately 15 feet wide with the exception of the haul road portion of the crest on the north embankment that was approximately 20 feet wide. The entire crest is exposed to vehicle traffic. Depressions and minor ruts, apparently due to vehicle traffic, were observed on the crest of each embankment (Photograph 1, 8 and 12). The crest surface appears to consist of compacted granular soils. A section of the crest of the south embankment has been excavated and remains open, apparently to facilitate the repair of a joint on the cinder pit sluice line (Photograph 5).

5. Ash Pond 1 - South Embankment Crest, Repaired 8 inch Diameter Sluice Line

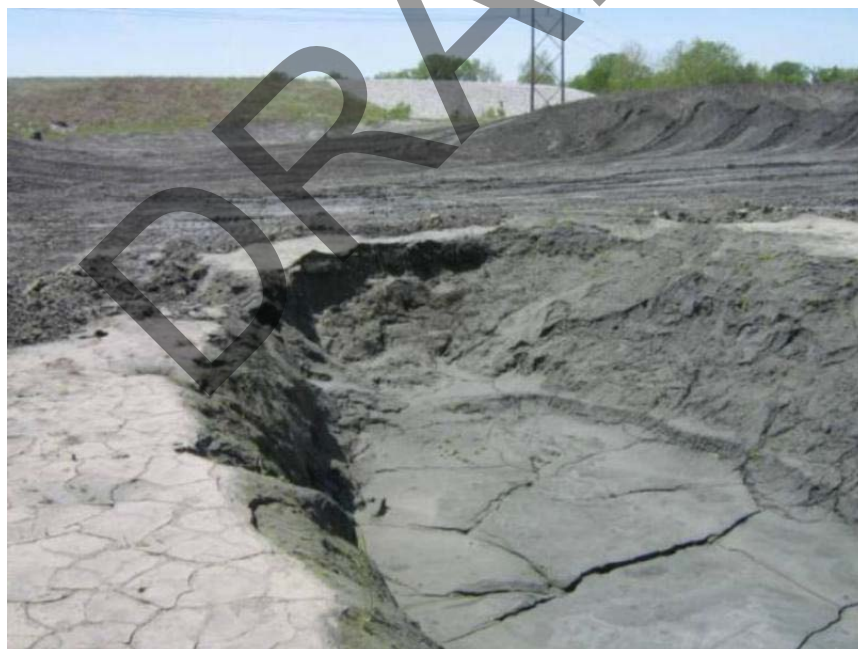
6. Ash Pond 1 - Excavation of Basin Floor (Approximately 6 feet deep, 55 feet long, 30 feet wide)

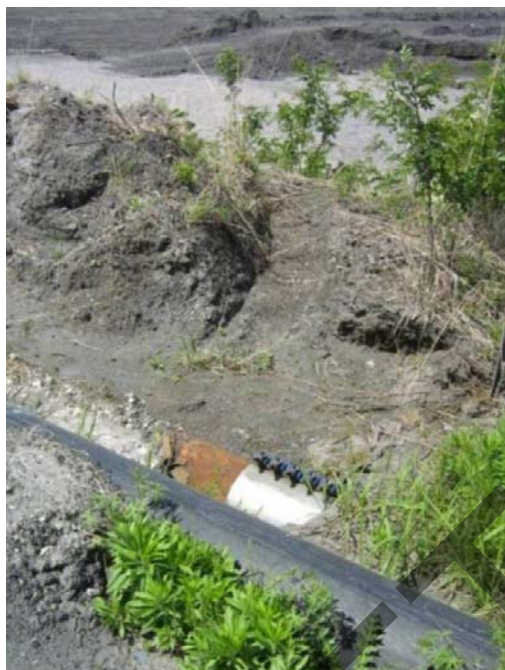
7. Ash Pond 1 - Sluice Line Repair at South Embankment Interior Slope

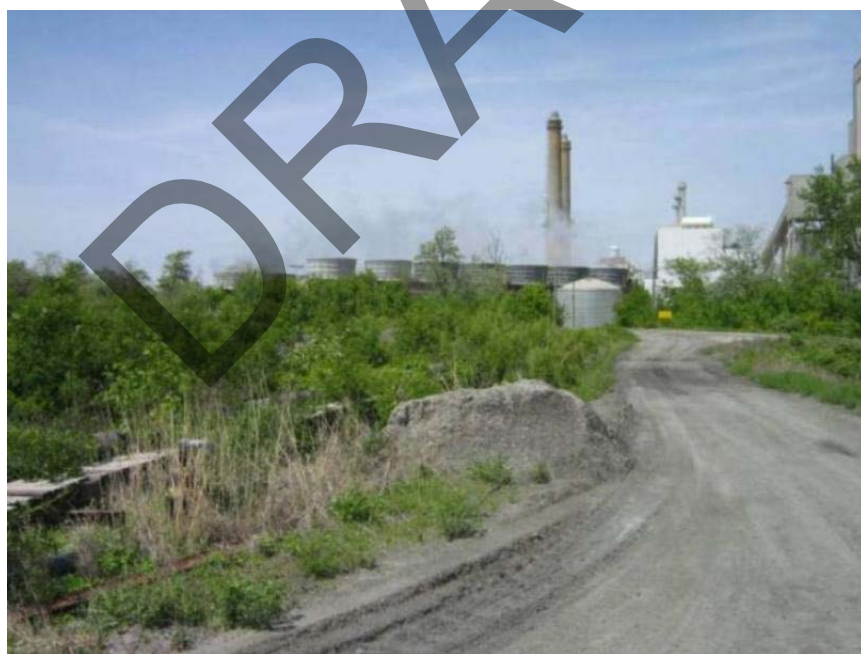
8. Ash Pond 1 - East Embankment Crest, Looking North

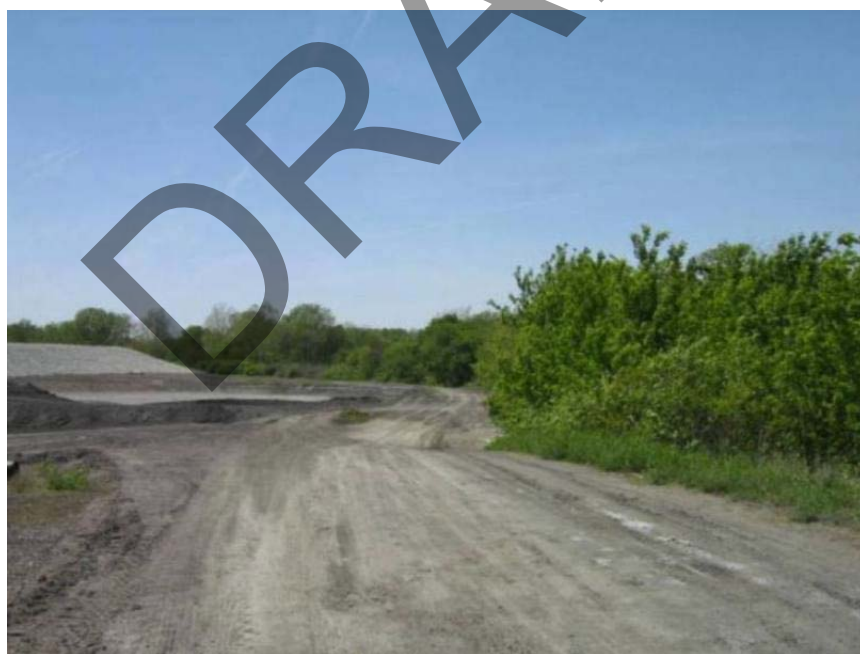
12. Ash Pond 1 - North Embankment Crest, Looking West, Depression Visible in Distance

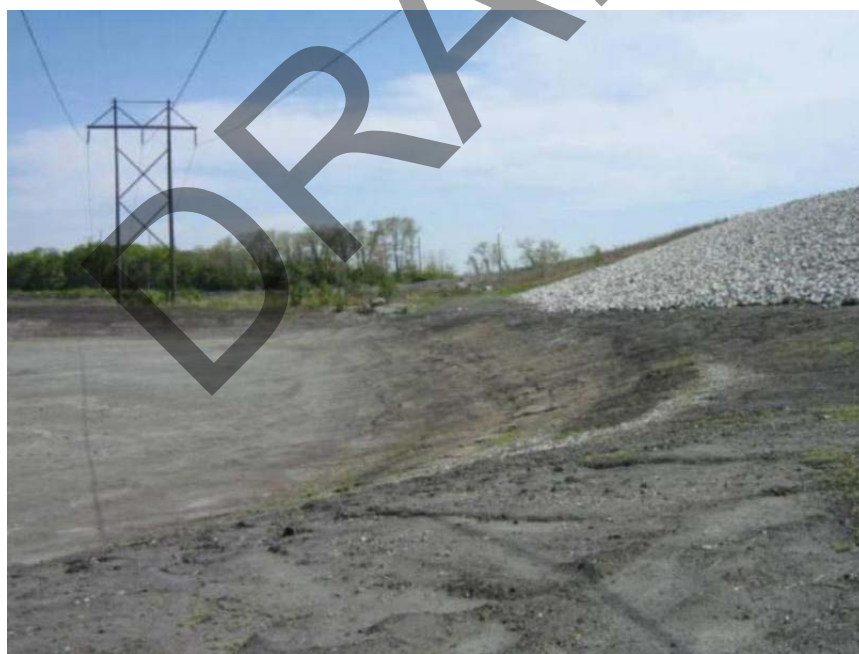
18. Ash Pond 1 - West Embankment Interior Slope, Looking South

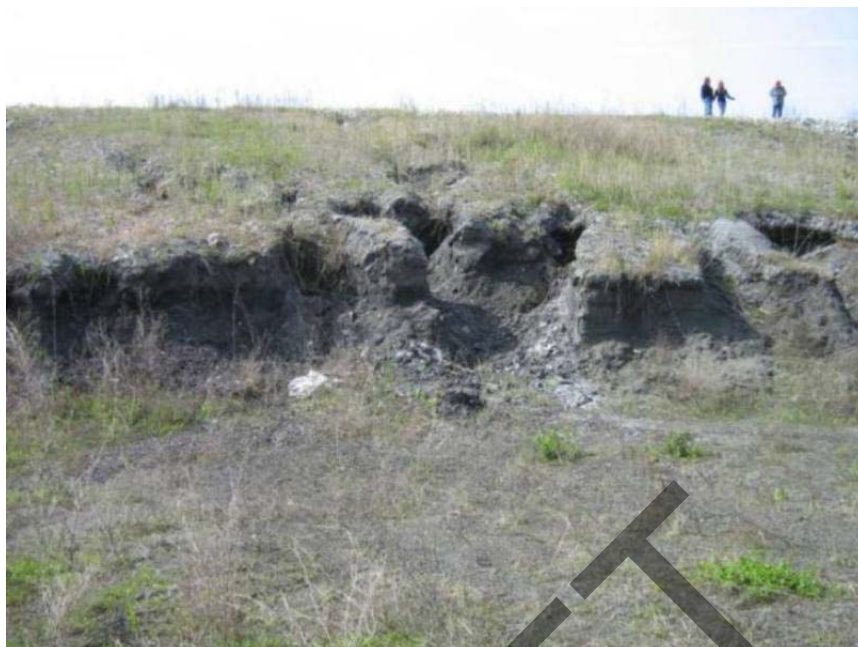
The interior slopes appear to be in generally poor condition. The interior slopes are approximately 3H:1V. No armoring of the interior slope is present and much of the pond's interior surface consists of exposed ash. There are deep erosion rills and significant surface sloughs on approximately 40 percent of the south embankment interior slope (Photographs 26, 33, 34 and 35).

34. Ash Pond 2 - Slope Failure of South Embankment Interior Slope,  
Looking South from Basin Floor

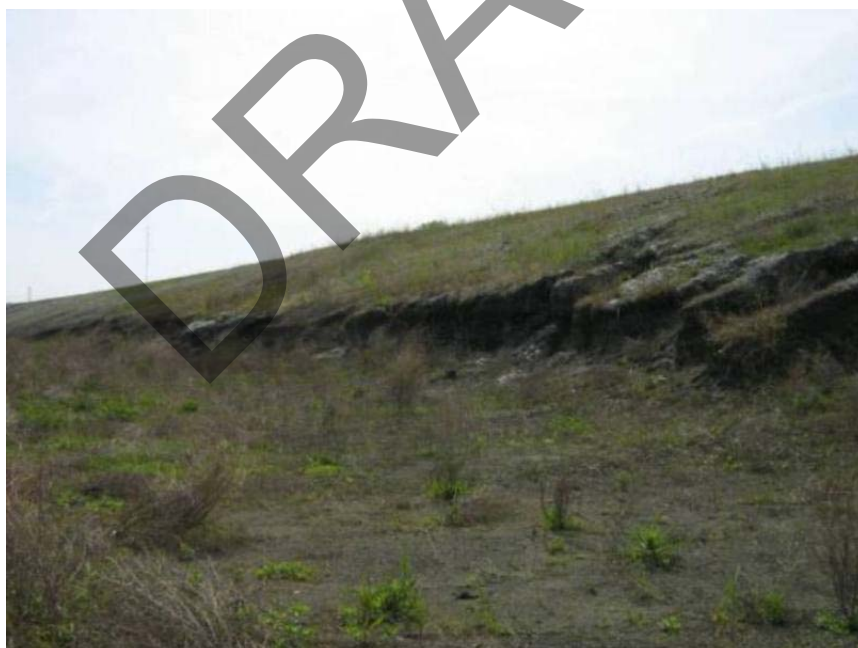
35. Ash Pond 2 - Erosion Rills and Slope Failure on South  
Embankment Interior Slope, Looking East from Basin Floor

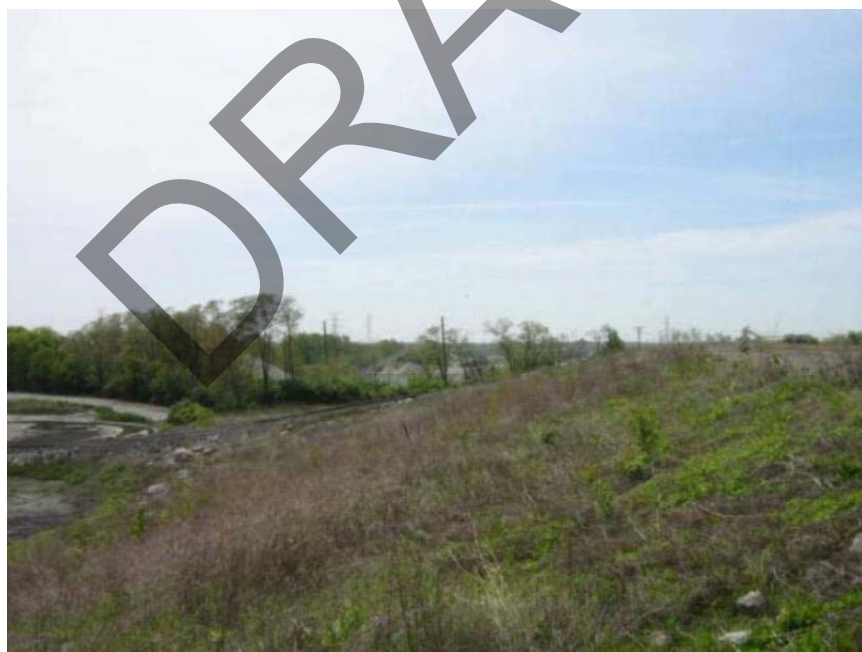
45. Ash Pond 2 - East Embankment Exterior Slope, Looking South

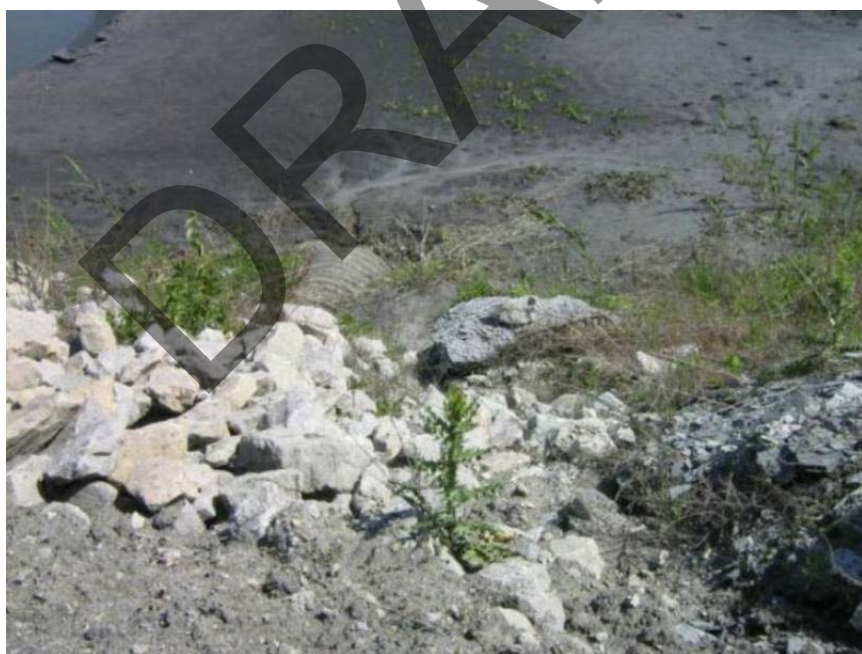
The outlet pipes appear to be in fair condition. Ash Pond 2A discharges to Ash Pond 2B and Ash Pond 1 (when active). Both outlet pipes are 30-inch-diameter CMPs (Photographs 47 and 59). The outlet to Ash Pond 1 was about 90 percent obstructed by sediment.

47. Ash Pond 2A - North Embankment Interior Slope, Riprap above  
30-inch-Diameter Outlet and Erosion Rill on the Right

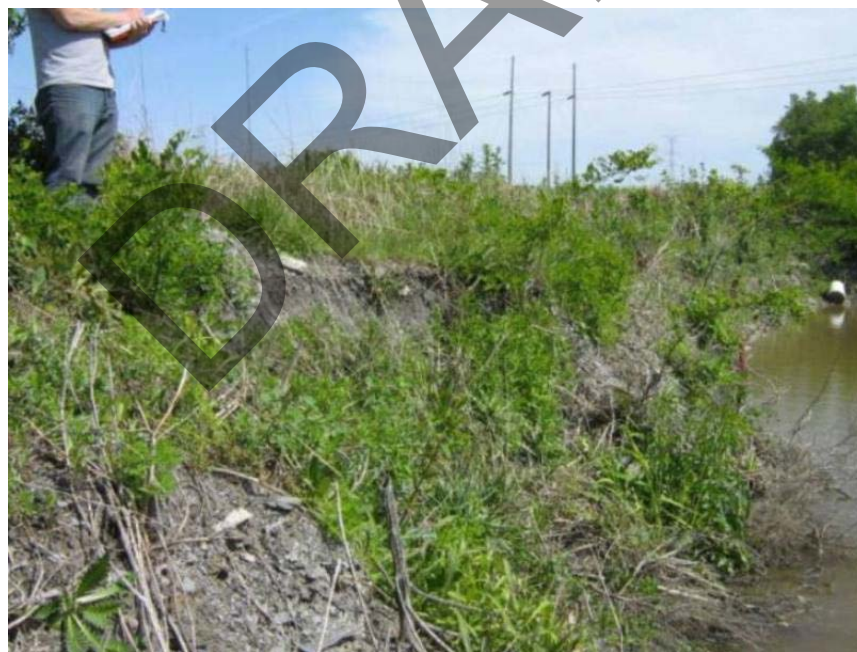
Scarps and beaching were observed on the east embankment where no armoring was present (Photographs 56 and 57). The embankment slope in these areas is approximately 1H:1V (Photographs 56, 57 and 58).

57. Ash Pond 2A - East Embankment Interior Slope, Looking South,  
Slope Failure

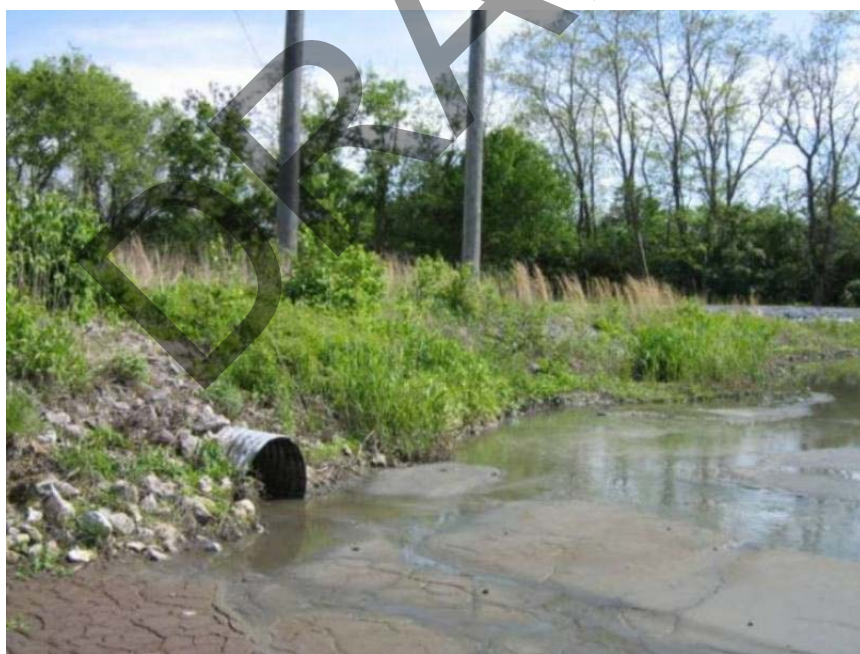
59. Ash Pond 2A - Outlet into Ash Pond 2B along the South Embankment Interior Slope, 30-inch-Diameter CMP

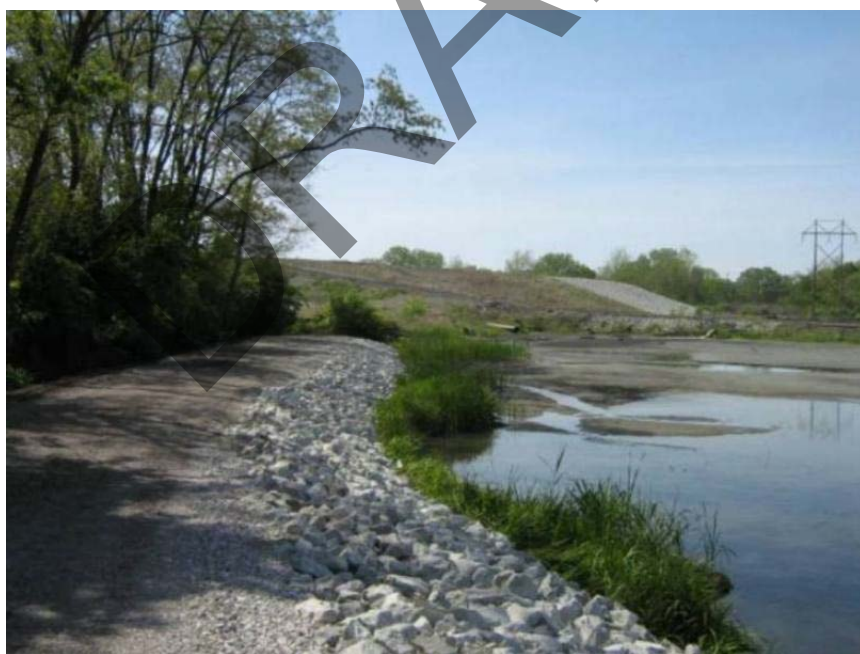
The crest appeared to be in fair condition (Photographs 51 and 61). In general, there are no signs of changes in the horizontal alignment. The crest serves as a vehicle access drive to the CCW impoundments. The average width of the embankment crest is 30 feet. A 5-foot-long section of the north embankment crest, in the vicinity of three 8-inch-diameter outfall pipes, has been eroded approximately 5 feet horizontally, resulting in a crest width of about 25 feet. This condition appears to infringe on the access drive (Photograph 46). Several minor depressions and areas of rutting were observed on the north embankment crest (Photograph 51).

The south embankment interior slope was armored with a layer of riprap to an elevation just above the water's surface (Photographs 50 and 61). Grass up to 18 inches high was observed along the waterline in this area (Photograph 60).

61. Ash Pond 2A - South Embankment Crest, Looking West

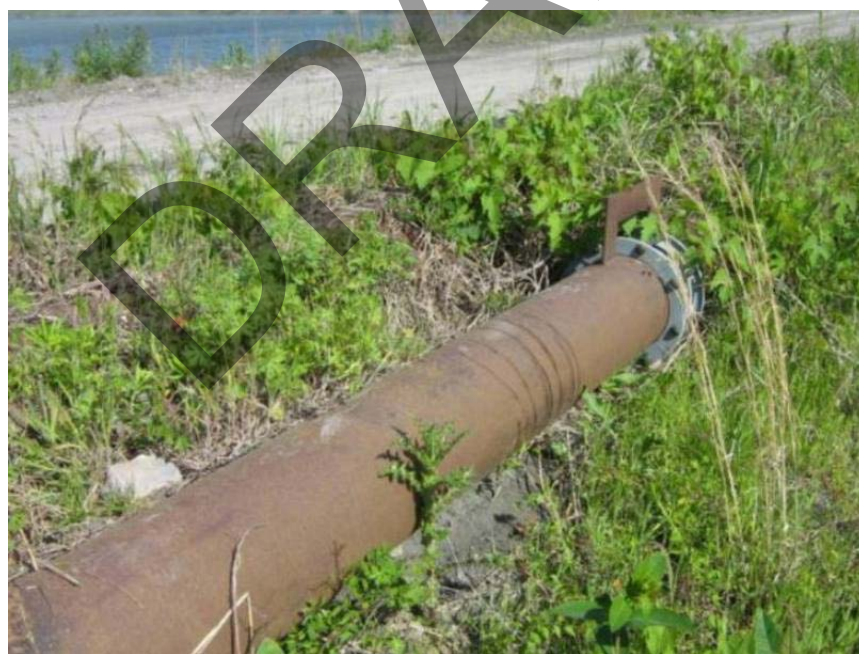
The exterior slopes appeared to be in poor condition due to the presence of trees and brush. Trees up to 4 inches in diameter and light brush were observed on the exterior slope of the south embankment (Photograph 65). Sluice lines/pipes from the cinder pit (hydroclone) and sump pump lines run along the north embankment (Photograph 69). Erosion was observed below pipes running along the east crest (Photograph 71). The south embankment slope was approximately 2H:1V.

71. Ash Pond 2B - Erosion below Sluice Line along the East Embankment Interior Slope

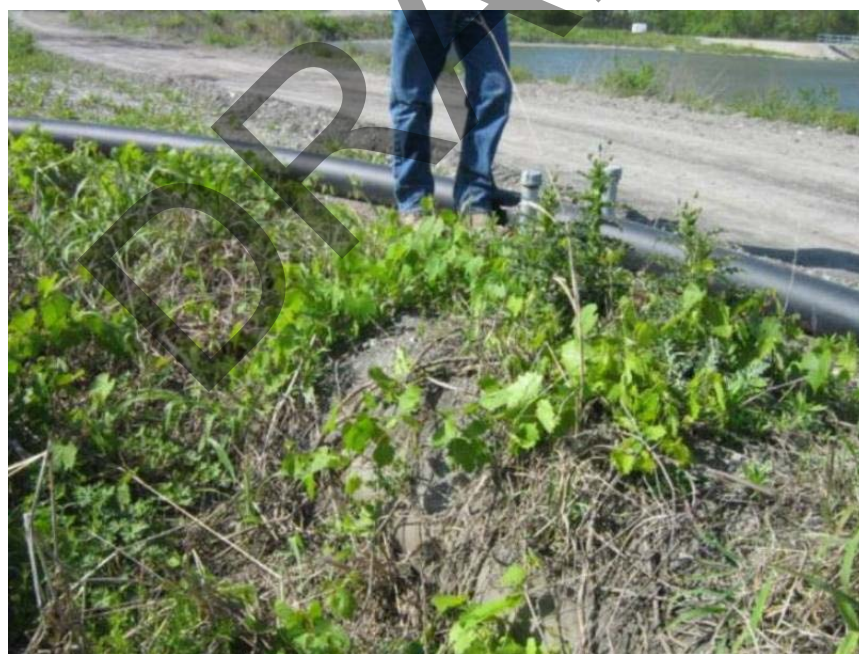
Erosion rills and areas of slope failure were observed on the south embankment (divider embankment with Ash Pond 2B). In the areas of slope failure, the embankment slope is approximately 1H:1V (Photographs 72 and 73).

The interior slopes appear to be generally in fair condition. Surface erosion was observed on the west embankment (Photograph 63) and at the eastern end of the north embankment interior slope (Photograph 73). The majority of the south embankment interior slope is armored with riprap (Photograph 62). The interior slopes generally appear to range from 2.5H:1V to 3H:1V, except in the areas of surface erosion and slope failure. In those areas slopes appear to be approximately 1H:1V.

73. Ash Pond 2B - Erosion and Slope Failure of Northeastern Embankment Interior Slope

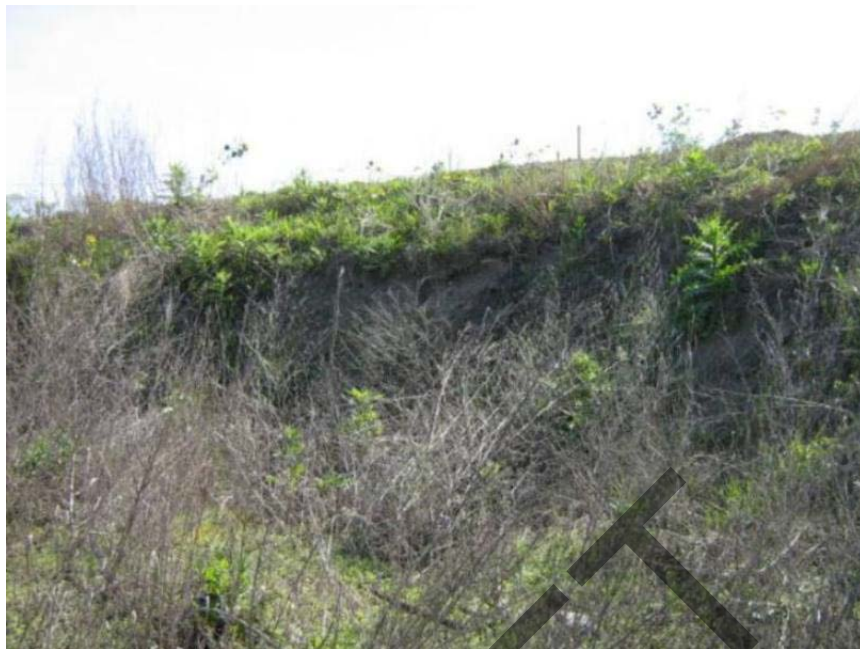
77. Ash Pond 3 - Local Slope Failure along West Embankment Interior Slope (Approximately 18 feet Long by 5 feet in Height)

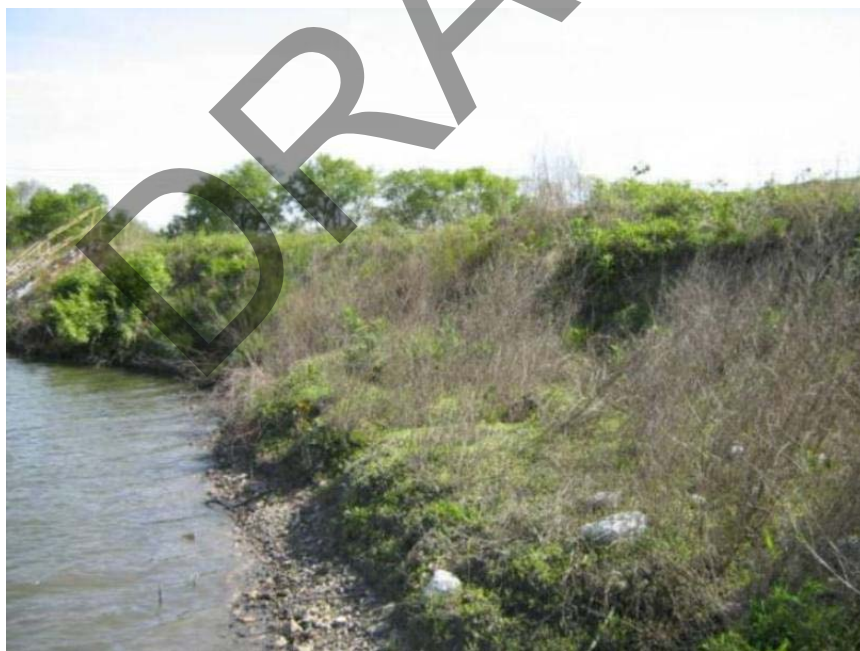
The south, east and west embankments were covered with medium dense vegetation ranging from approximately 18 to 48 inches in height. The exterior slopes on the west, south and east embankments ranged from approximately 2.5H:1V to 3H:1V. Riprap, with an underlying geotextile has been placed on sections of the east and south embankments, apparently for erosion protection (Photographs 46, 47, and 79). Surface erosion was observed along portions of the south embankment. An erosion rill on the south embankment had undercut plant sluice lines by as much as 14 inches across a distance of approximately 10 feet (Photographs 48 and 49). The east embankment had areas of erosion, including sections with apparent surficial slope failures and undermining (Photographs 78, 81 and 82).

78. Ash Pond 3 - Slope Failure and Beaching along West Embankment Interior Slope

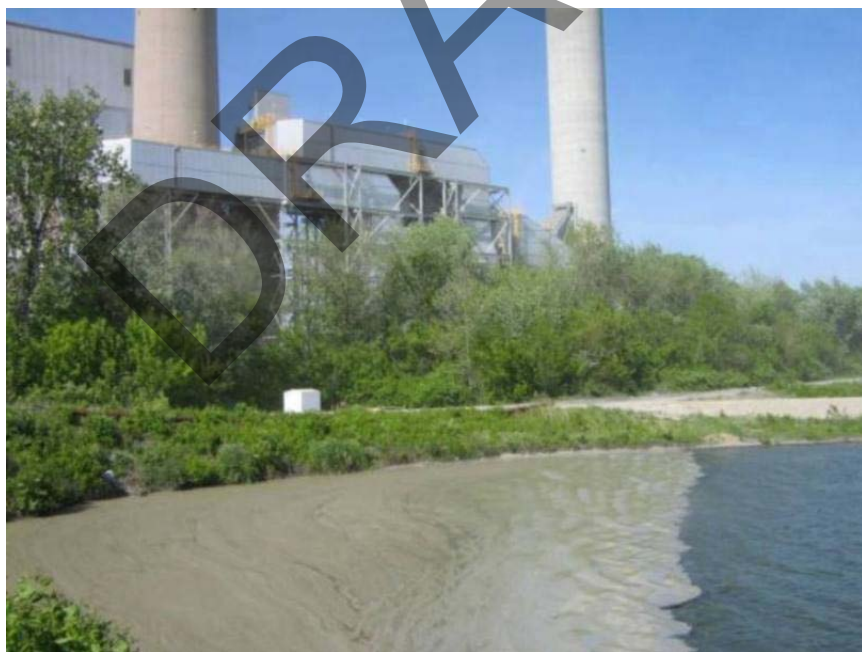
80. Ash Pond 3 - Fines in Northwestern Corner of Pond

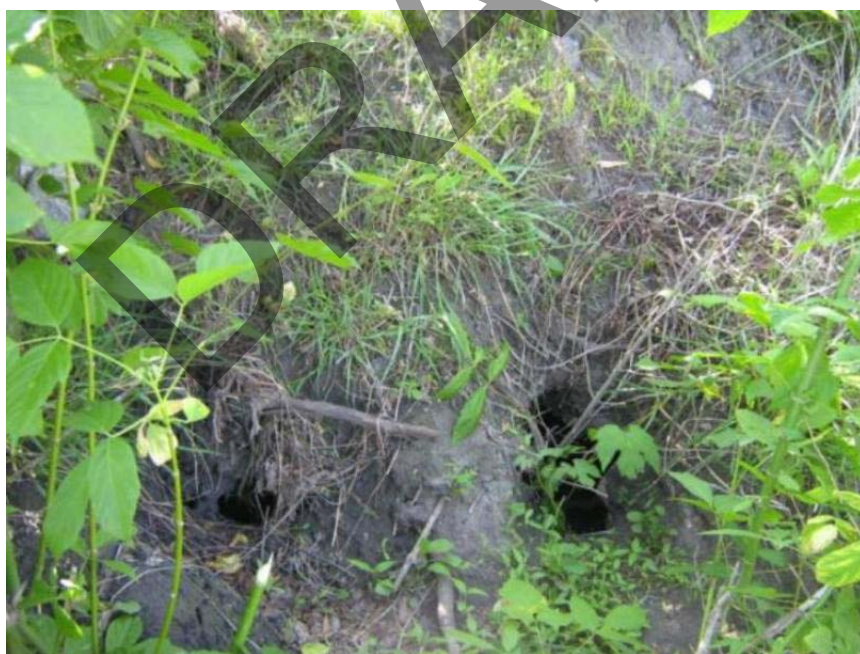
82. Ash Pond 3 - Sink Holes on the West Embankment Interior Slope

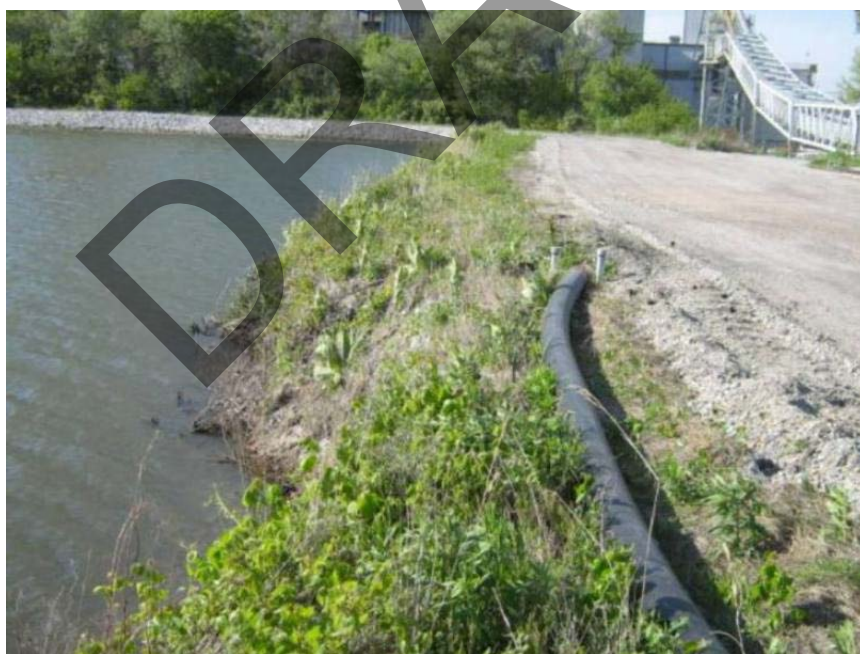
94. Ash Pond 3 - Slope Erosion along East Embankment Interior Slope so as the Distance between the top of Slope and Hydroclone pipe is Approximately 2 feet

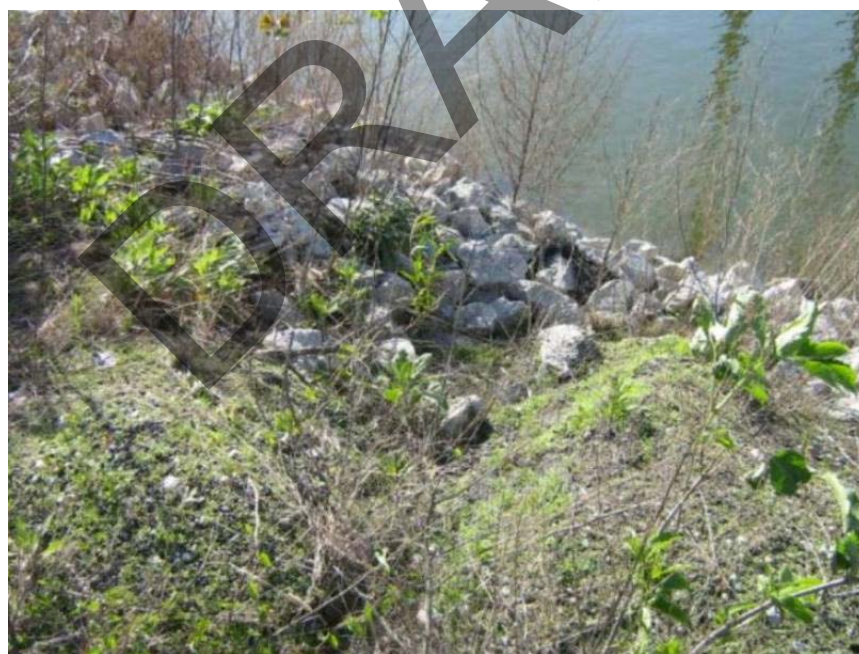
98. Ash Pond 3 - Erosion Rill above and Adjacent to Riprap along South Embankment Interior Slope

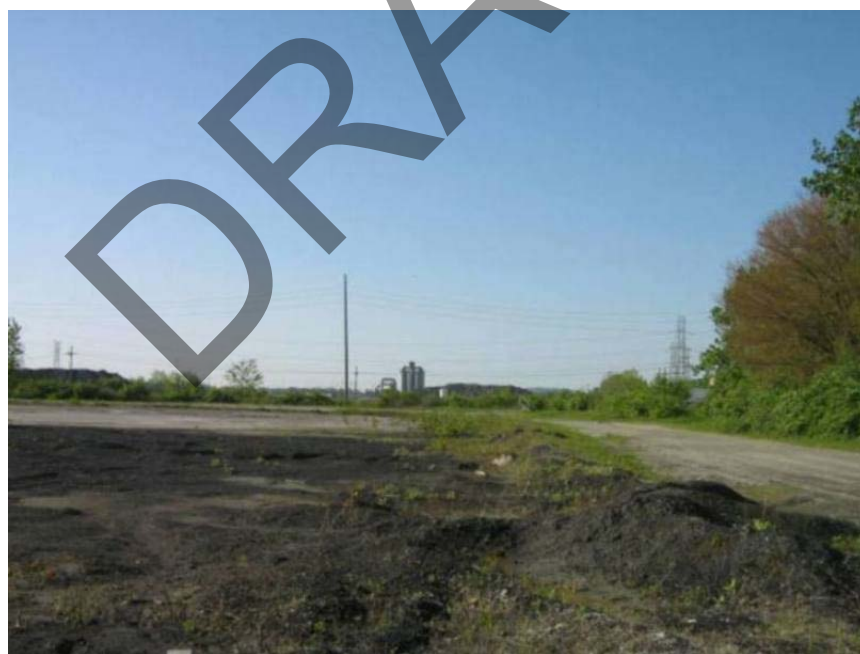
118. Ash Pond 4 - West Embankment Interior Slope, Looking South,  
Ash Sediment Near top of Crest

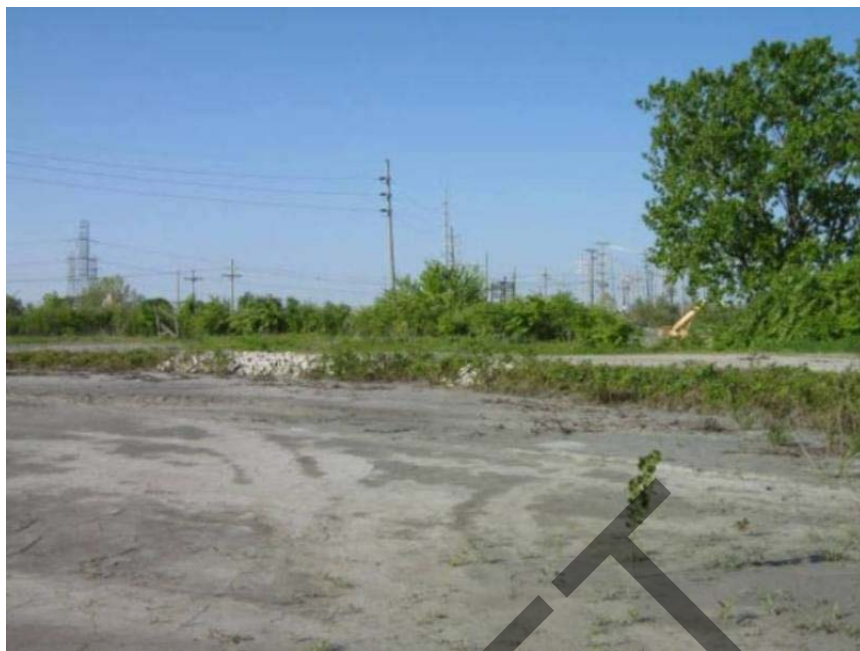
119. Ash Pond 4 - Riprap used to Repair Erosion at Western Embankment Interior Slope

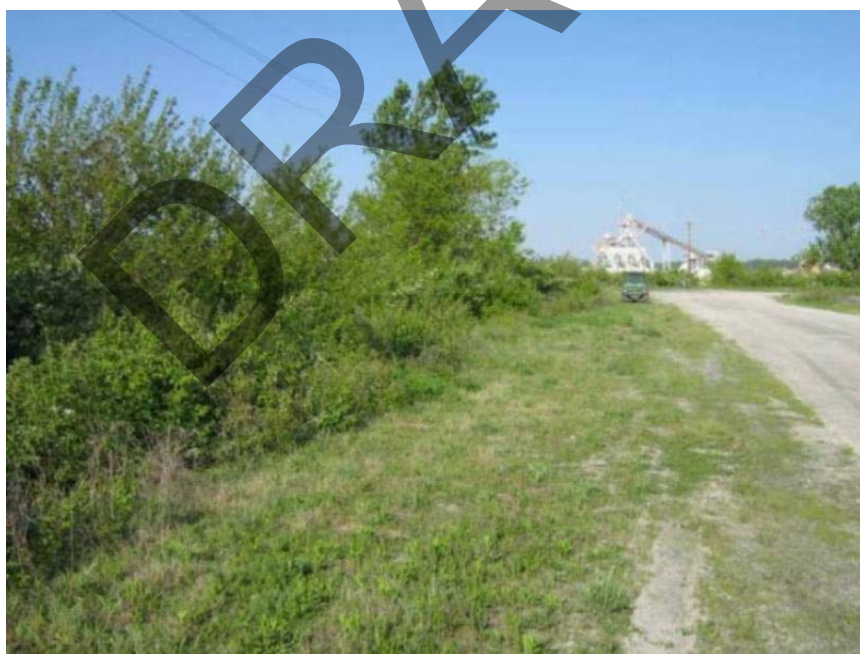
124. Ash Pond 4 - South Embankment Exterior Slope, Looking West, Heavy Vegetation Present

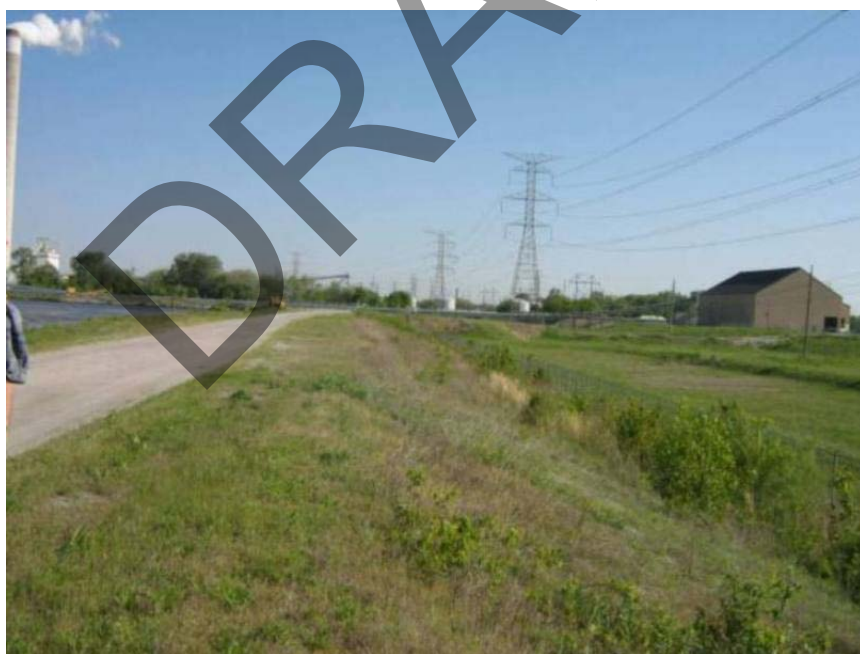
128. Ash Pond 4 - East Embankment Exterior Slope, Looking North,  
Established Vegetation on Slope, Brush and Saplings at Base of Slope

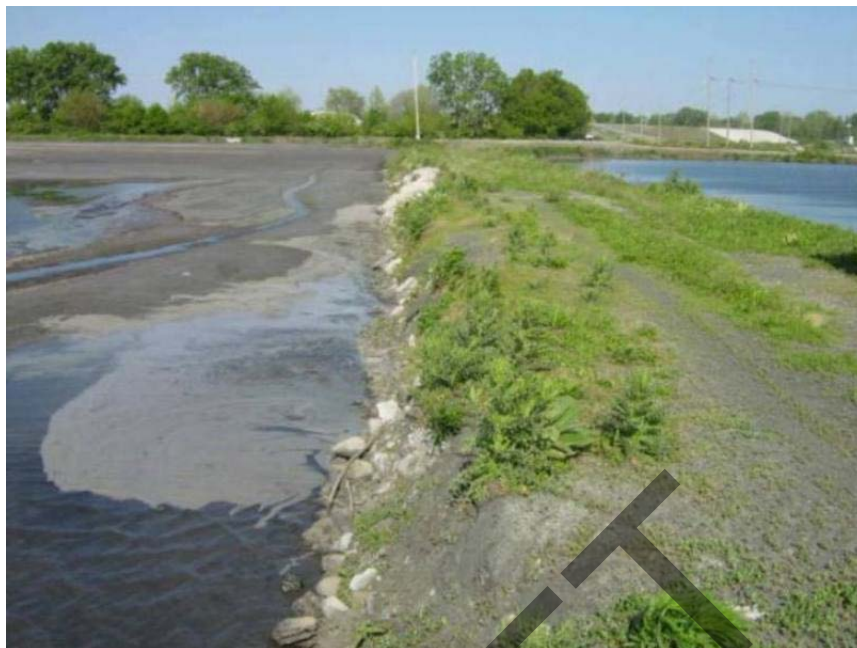
137. Ash Pond 4 - Slope Failure along the North Embankment  
Interior Slope, Looking West

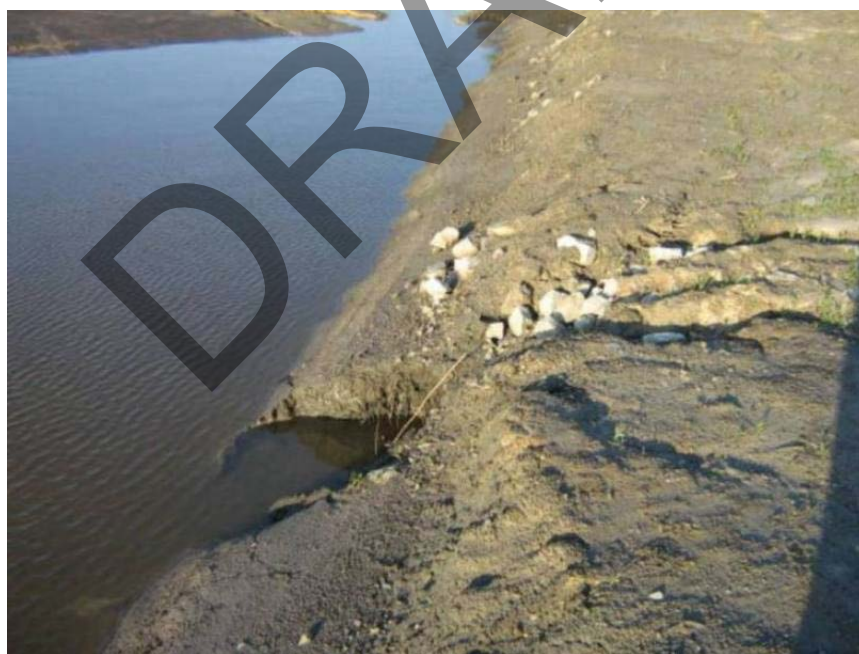
144. Ash Pond 4A - Erosion Rill on North Embankment Interior Slope

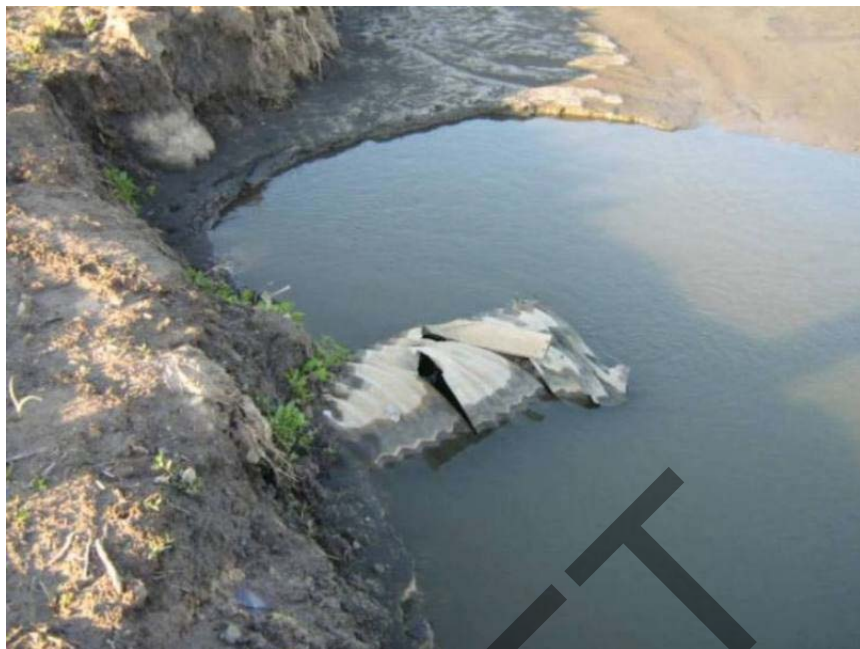
149. Ash Pond 4A - Inlet/Outlet to Ash Pond 4B at Southeastern Corner of Pond, Damage to 30-inch-Diameter CMP Visible

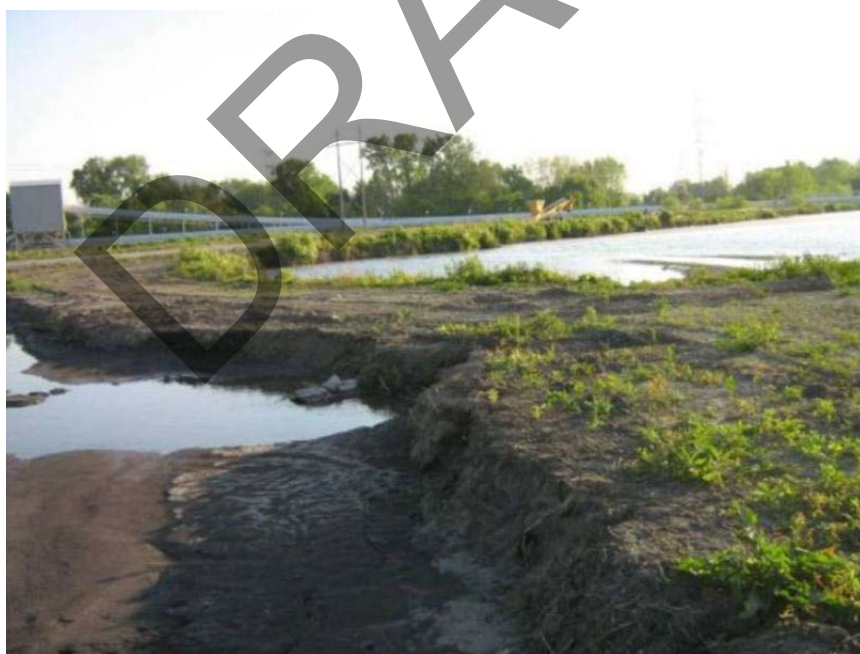
150. Ash Pond 4A - Erosion and Slope Failure along South Embankment Interior Slope, Looking East

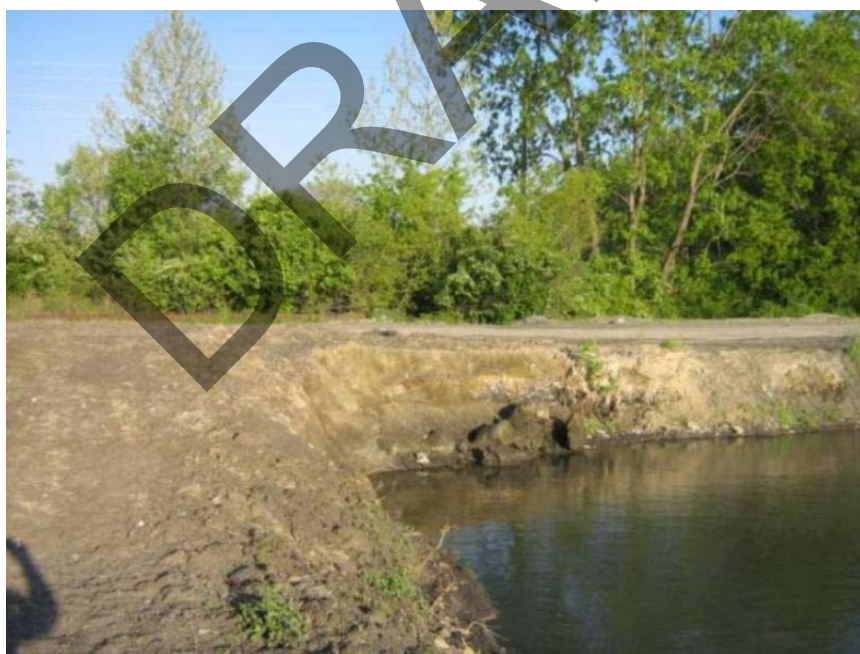
152. Ash Pond 4A - Slope Failure West Embankment Interior Slope,  
Looking West

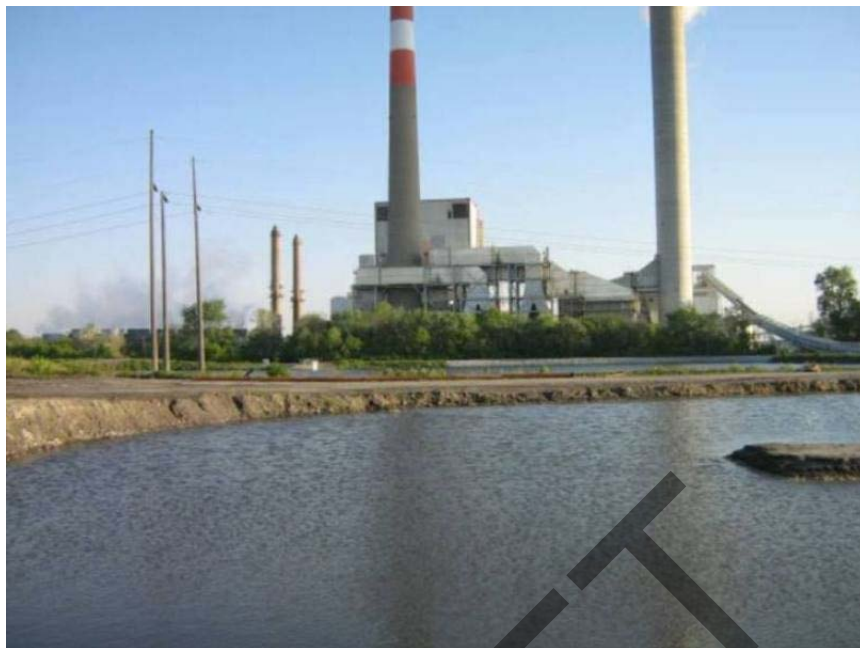
153. Ash Pond 4A - Erosion Rills and Slope Failure at North Embankment Interior Slope, Looking North
